## THE CASE STUDY OF CONDITIONAL STATUS OF EXISTING MAJOR BRIDGE AND ITS REHABILITATION

**K.ASUDULLAH KHAN**

Team Leader, Sr.Bridge Engineer, Feedback Infra Pvt Ltd, Mangalore, Karnataka, India

(A) Strengthening of existing Maneru Bridge at Karimnagar town, Telangana.

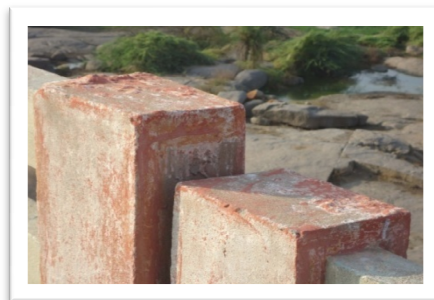
In the month of June, 2012 the concerned authorities including author observed severe vibrations in the bridge and at the same time distress in bearing regions of pier P11 and Pier P14. The following physical conditions were observed from the inventory:

Figure 3: Level Difference Observed in Hand Rail at Pier P-11 & Pier P14

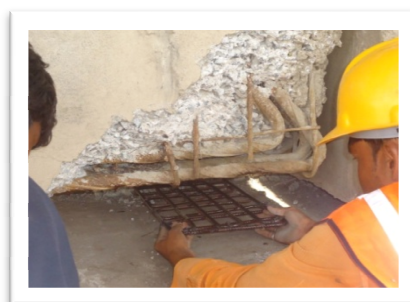
- From the ultra pulse velocity test the quality of concrete in tested locations of the longitudinal girder at bearing on Pier P14, Pier P11, and Pier P5 was observed to be poor at the soffit region and improvement of quality was observed in upper regions.
- From the UPV test on diaphragm beams (cross girders) on piers P5, P11 & P14 it is inferred that the quality of concrete was observed to be poor at the bottom regions of the beams and require necessary restoration measures before lifting the structure
- Bearing pads were observed to be in distressed condition at many locations
- All the expansion joints were clogged and to be removed & replaced with new

Figure 4: Reinforcement Bars Exposed At the Bearing Region of Main Girder

- The honey combing that found at the bearing regions of Main girders is because of dense reinforcement and uncompacted concrete
- The bearing pads bulged and failed because of using substandard bearing sizes
- Expansion joints are clogged and not functioning because of not attending maintenance at regular interval.
- The existing Manair Bridge distressed because of non attenance of maintenance at regular interval.
- The existing bridge should have to inspect its conditional status at regular interval as per Bridge maintenance manual to check it's functioning but that not happened in this case.

- In view of the poor quality of concrete and low pulse velocities observed in diaphragm beams(cross girder) at bearing regions it was recommended to grout the bottom region of the beam with micro fine cement
- In view of the crushed, segregated and poor quality of concrete observed in longitudinal girders at bearing regions, it was recommended to remove this concrete portion and replace with free flow micro concrete by lifting the super structure using hydraulic jack system
- In view of the crushed & deformed bearing pads observed, it was recommended to remove these bearing pads and replace with new ones
- The bulged concrete portion in wearing coat at the expansion joint region shall be removed upto a minimum of 500mm on the both sides of joints and filled with micro concrete. New compression seal joint shall be fixed in the expansion joint region as per standard practice.

- The existing loose concrete in the bearing region of main girder shall be removed using concrete chippers
- Exposed reinforcing bars shall be cleaned thoroughly to remove the rust and scales if any

- Two coats of anti-corrosive chemical paint shall be applied to exposed reinforcing bars
- Free flow micro concrete(pre packed) shall be filled in this region by using slurry tight shuttering as detailed in sketch and cured as per standard practice

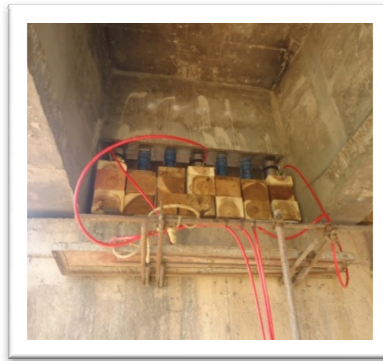
Figure 5: Cross Girder Lifting in Progress

- The pressure grouting shall be done to diaphragms beams(cross girders) and main girders for strengthening
- Hydraulic jacks & mechanical jacks shall be placed below the end of diaphragm beams as explained sketch for lifting of main girders

- The hydraulic jacks shall be connected to a single power pack to facilitate uniform lifting
- The span shall be lifted with hydraulic jack system with single power pack upon the required height and supported on mechanical jacks and wooden sleepers

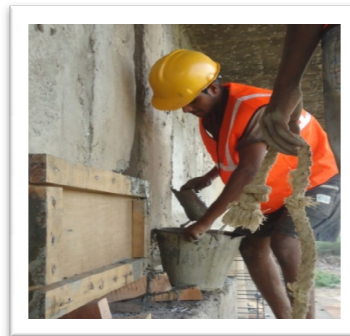
Figure 6: Micro Concreting at the Bearing Region of Main Girder

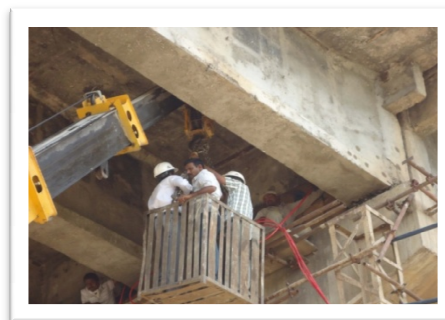
Figure 7: Bridge Inspection under Progress

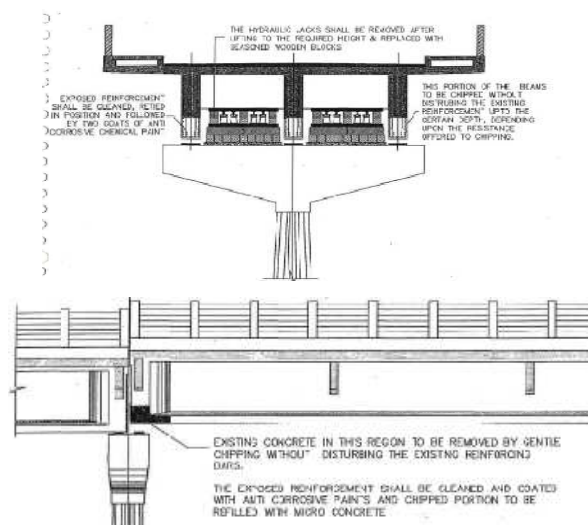
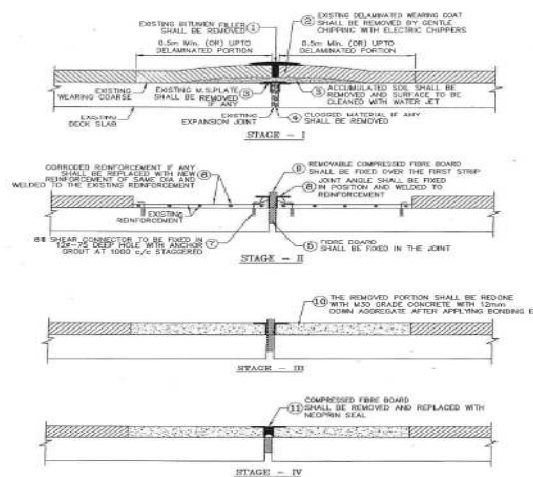
- All expansion joints in the deck portion were observed to be clogged and were in distressed condition
- The existing bearing pad size 265x265x99 was observed to be different from the dimensions of bearing pad recommended in MOST drawing I.e500x360x99

Figure 8: Replacement of Expansion Joint

- The main girder lowered on new bearing pad with support of jacks
- The replacement of expansion joint shall be taken up as shown in sketch.
